Technical Report CHL-99-13
July 1999

Monmouth Beach, New Jersey: Beach-Fill “Hot Spot” Erosion Evaluation

Report 2 Functional Design of Shore-Protection Alternatives for Beach-Fill Longevity

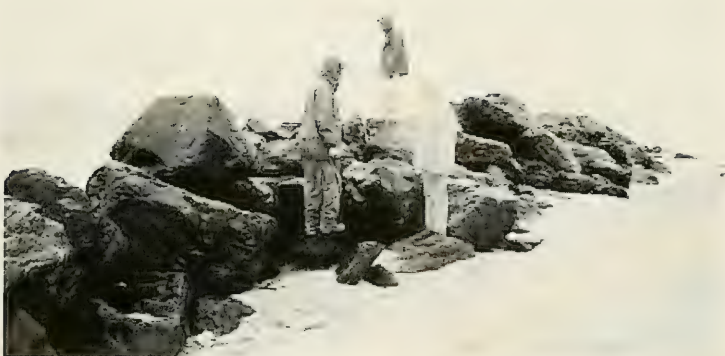
Figure 34. Groin 44 in March 1998

Groin 44 appears to be impounding sand updrift (to the south) as intended (Figures 34 and 35). Groin 46 also impounded sand until the fall of 1997 when it was notched (a 100-ft-long (at mhw line), 7-ft-deep section of the central portion of the groin was removed) to increase its permeability. Since then, no sand has been impounded. Little influence on shoreline position by the notching is evident at the remaining groins (e.g., Groin 45, Figure 36).

The relation between structure condition (stone breakage, deterioration, or shifting) and structure performance at Monmouth Beach is not known. Though Groin 44 is impounding sand, its “fair” condition gives no indication of the existence of any broken or deteriorated stones. Groin 46 was performing as
